Winhall, Vermont

3 River Road

A Building Condition Assessment Report
and
A Community Center Cost Estimate with
Conceptual Designs

Prepared By: Cotton Belaski Architectural Services
598 Route 30 Newfane, Vermont 05345
802-365-7277

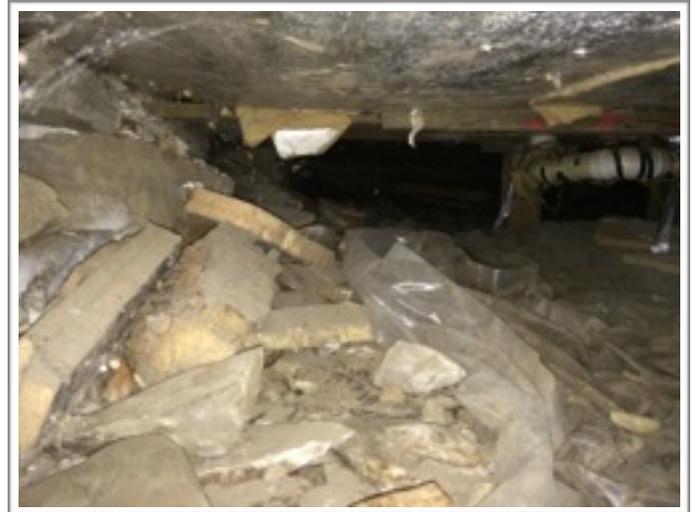
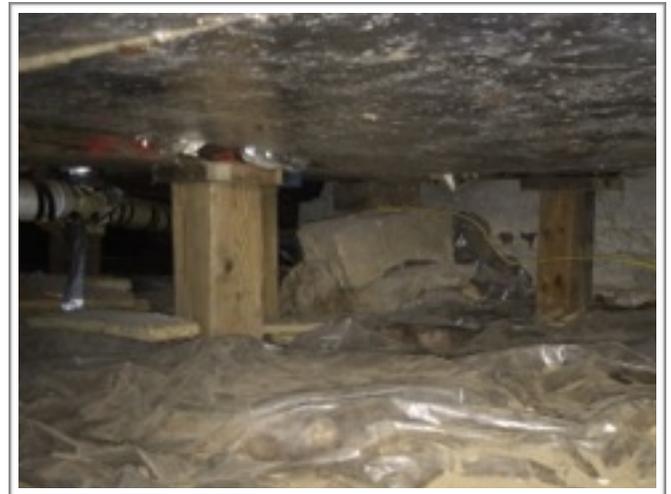
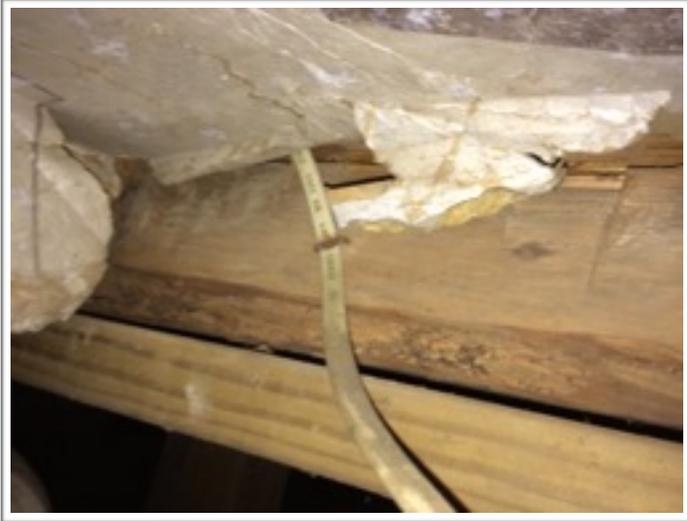
The existing foundation is mortared stone with a crawl space of 18” - 30” clearance. Light is visible through parts of the wall, and therefore the space is not entirely weather tight.

The crawl space floor is dirt, though some polyethylene has been laid down. There is still dampness in the space that appears to have contributed to some structural deterioration of the wood framing.

There are a number of randomly spaced wood posts scattered through-out the space to shore up first floor framing and support bearing transferred from the second floor.

Rigid insulation has been applied to the underside of the floor framing that conceals close inspection of the floor framing members, however there does appear to be some deterioration of the framing, possibly caused by exposure to moisture from the crawl space over the life of the building.

It appears the rigid insulation was installed rather loosely or has worked loose over time. Unfortunately, this type of insulation must be installed firmly and continuously with no gaps to be effective, thus the insulation is ineffective.

A new foundation would increase energy efficiency, allow inspection and repair of the framing, provide a code required fire-rated mechanical space, as well as storage space, and provide a

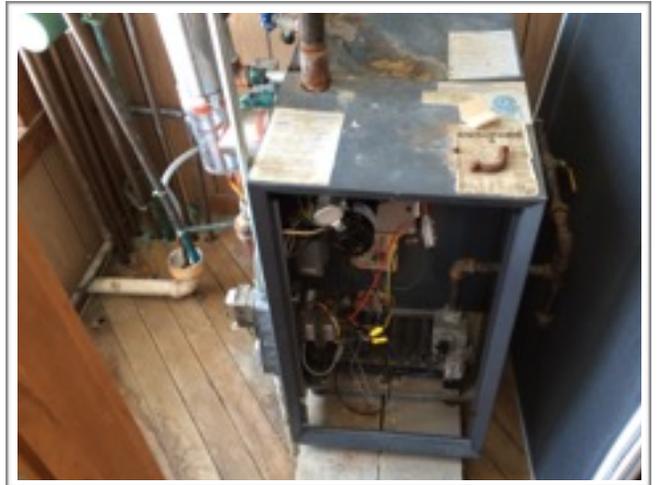
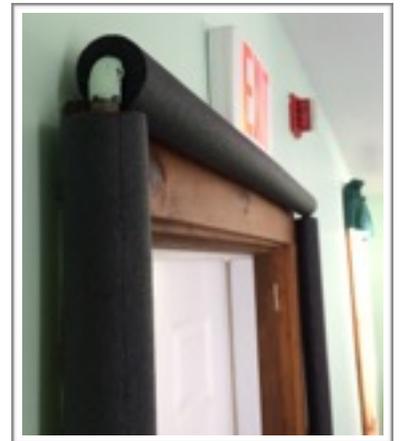
The existing propane boiler is located on the second floor in an open closet. The boiler provides hot water for the perimeter baseboard radiation on both floors. It should be noted that on the first floor this radiation piping is exposed and poorly fastened, presumably to avoid dropping into the crawl space.

Upon inspection, this boiler is very near the end of its useful life. The current installation of this heating system does not meet current State requirements for of a fire-rated room provided with clearances, limited area sprinkler, and combustion air.

With a new foundation, this could easily be provided in the basement, away from any occupied areas.

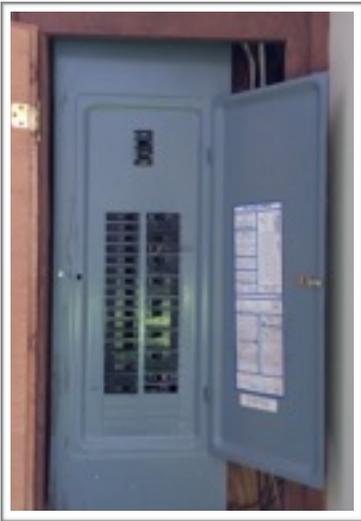
The existing 200 Amp electrical system is reasonably up to date. However, the renovations to the toilet room, removal of the vault, interior changes, and a new foundation with access stair will require new electrical work.

With a new basement, it is logical that the building's electrical panel would be relocated to this area. Also, depending on the final layout of the first floor, some lighting changes should also be expected.

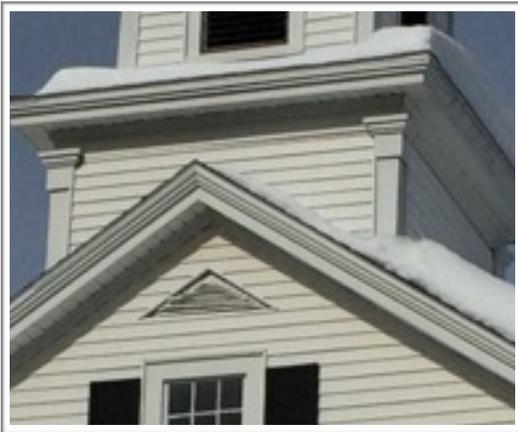
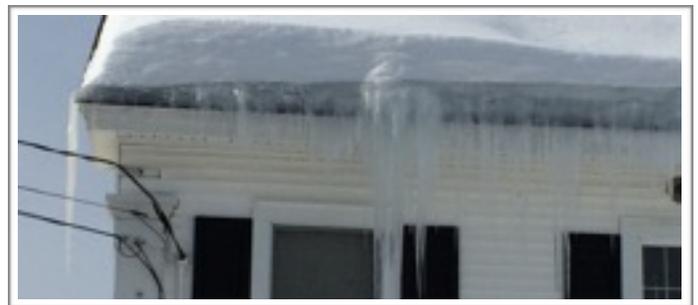
The existing attic is framed with four kingpost trusses with rough cut 2"x 8" purlin rafters and rough cut 2"x8" ceiling joists

The space between the ceiling joists is filled with fiberglass batt insulation. On top of the ceiling joists, there are additional 8" batts of fiberglass insulation loosely lain.

From the outside there appear to be some significant ice dams. We believe that removal of the top layer of

batt insulation, and installation of 8"-12" of cellulose insulation would form a more continuous insulation layer. Also, verifying the correct attic ventilation with any necessary adjustments would increase the energy efficiency and help prolong the life of any roofing.

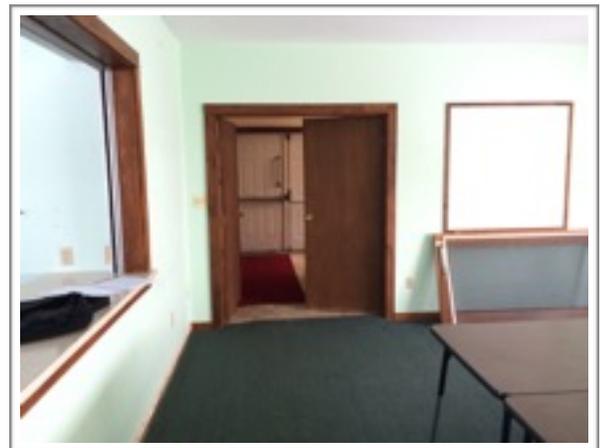
The first floor seems to have had plywood placed over the original strip wood flooring.

Carpet has been installed throughout the first floor with the exception being linoleum at the entry and toilet room. The existing carpet and vinyl flooring should be replaced with new durable, inexpensive and tasteful flooring material.

The Second Floor has the original strip flooring. This flooring should remain and be re-finished.

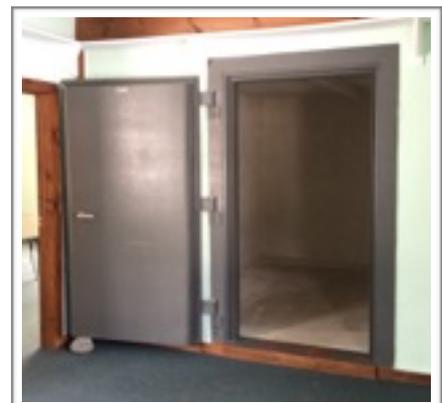
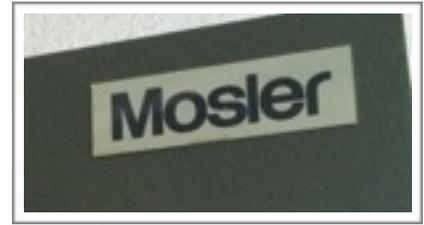
The existing vault, located in the northwest corner of the first floor, is constructed of masonry block walls and a concrete floor and ceiling.

The concrete floor was placed approximately 3" above the main floor.

This level change would make this space non-compliant with ADA requirements. In the crawl space (below the vault) there are rough concrete foundation walls used to support the vault's structure.

Due to the ADA non-compliance, lack of natural light and ventilation and the uncomfortable acoustic resonance in the space we recommend the vault and supporting concrete walls be demolished and removed to allow for best future use.
